## **Ishynique McCoy v. T-Mobile Store, et al.**

### **Electrical Evaluation**

Loss Location: Philadelphia, Pennsylvania

Date of Incident: July 17, 2016

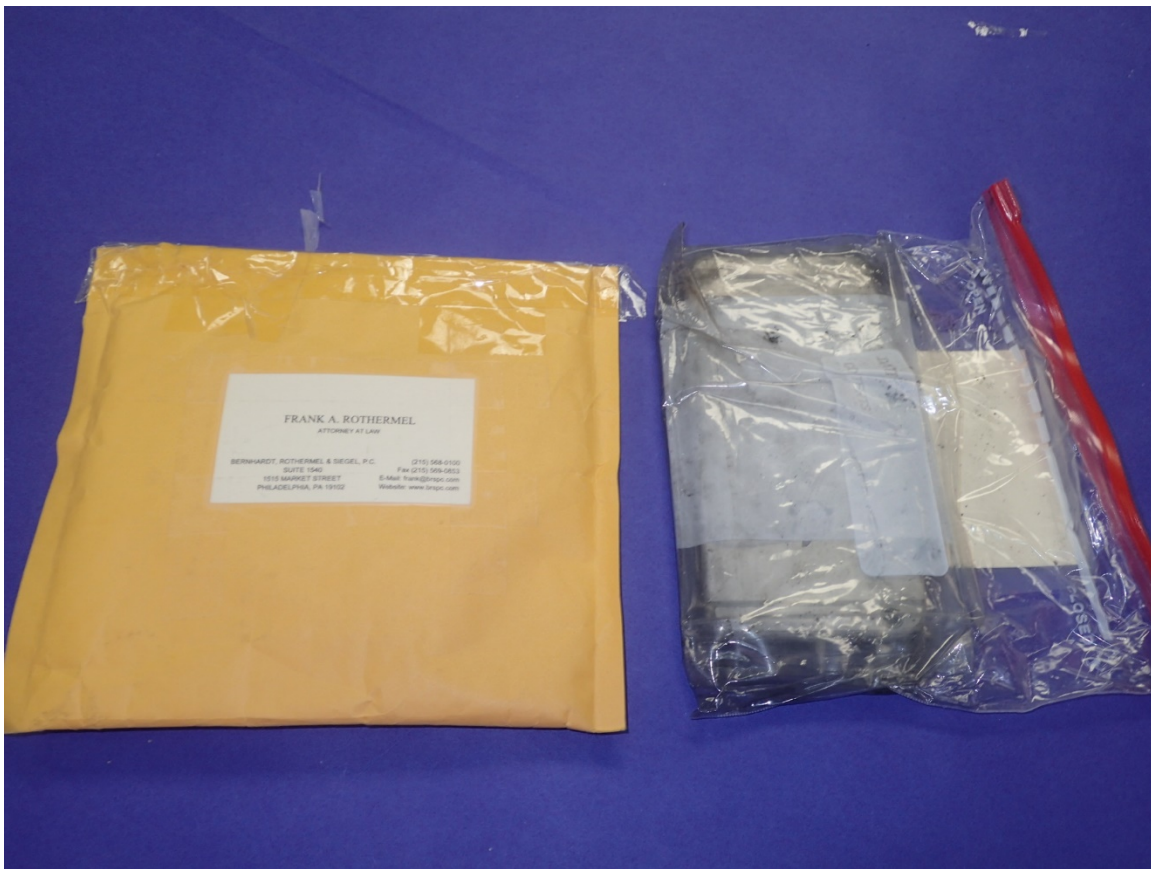
The artifacts (as shown in **Figure 1**) were examined in detail and consisted solely of the Apple iPhone 6 Plus cellular phone from the McCoy incident indecent.

**Figure 1: Artifacts retained from the McCoy incident.**

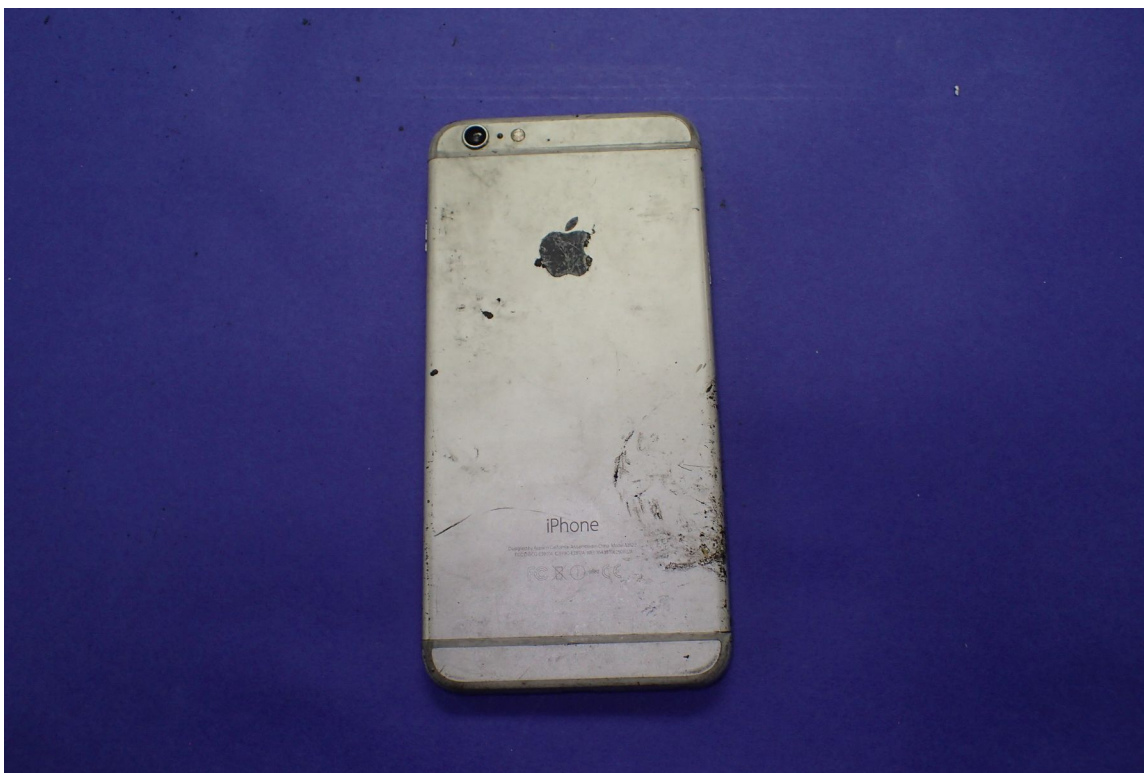
Examination of the artifacts began with the top side of the Apple iPhone, Model No. A1522 with an IMEI No. 354387062506228, identifying the phone as an Apple iPhone 6 Plus. Examination of the rear of the phone revealed no visible damage to the phone or the front camera, as seen in **Figure 2** and **Figure 3**. Examination of the front of the phone revealed damage to the screen that appeared to be cracked and a gap between the front and rear as seen in **Figure 4** and **Figure 5**. The examination of the phone then continued with the interior to expose the battery cell as well as all the connection points associated with items that were replaced by FedEx Supply Chain, which were as follows:

**Figure 2: Rear of the subject Apple iPhone 6 Plus.**

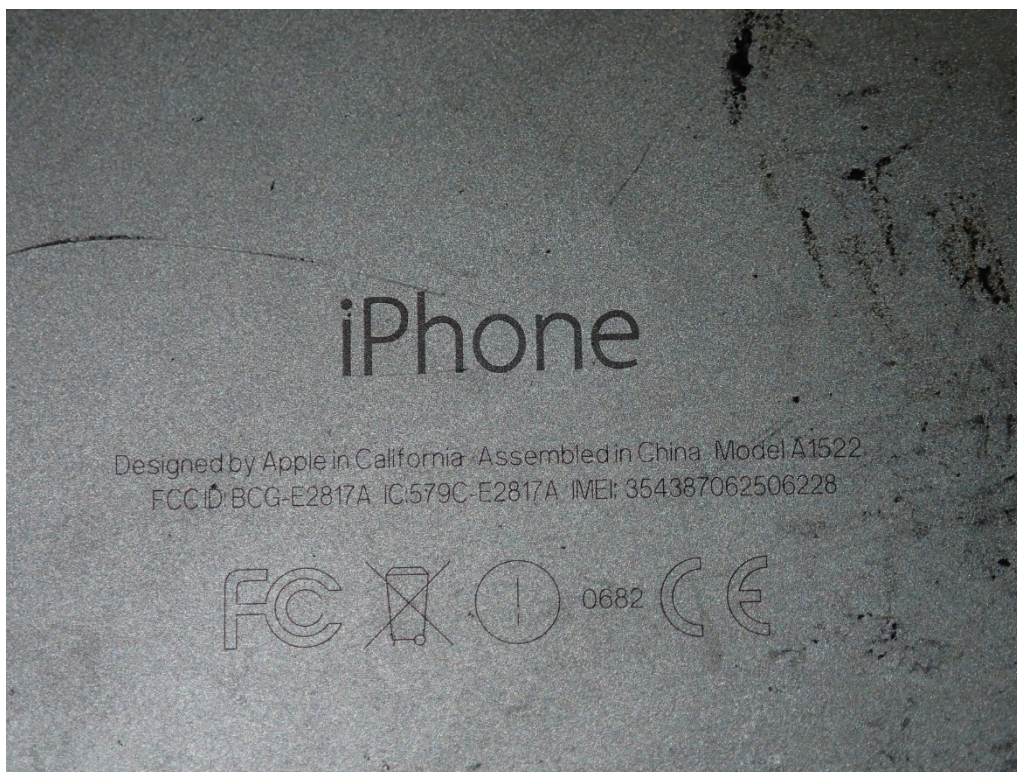
**Figure 3: Closeup of the Apple iPhone information.**

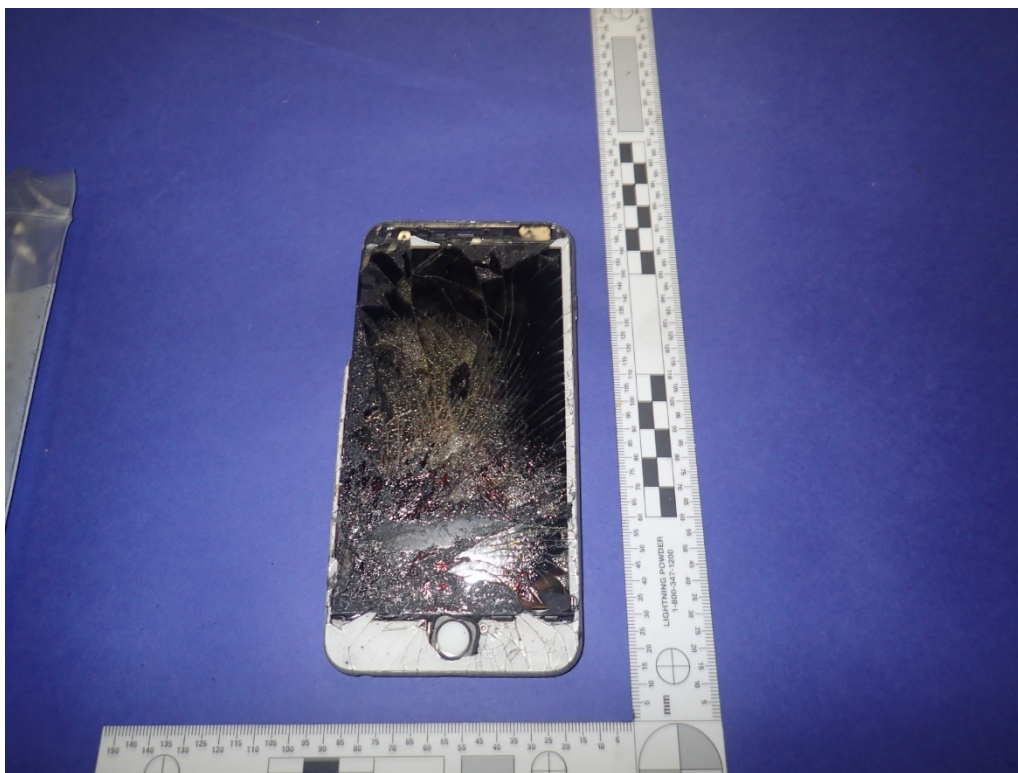
**Figure 4: Front of the subject Apple iPhone 6 Plus.**

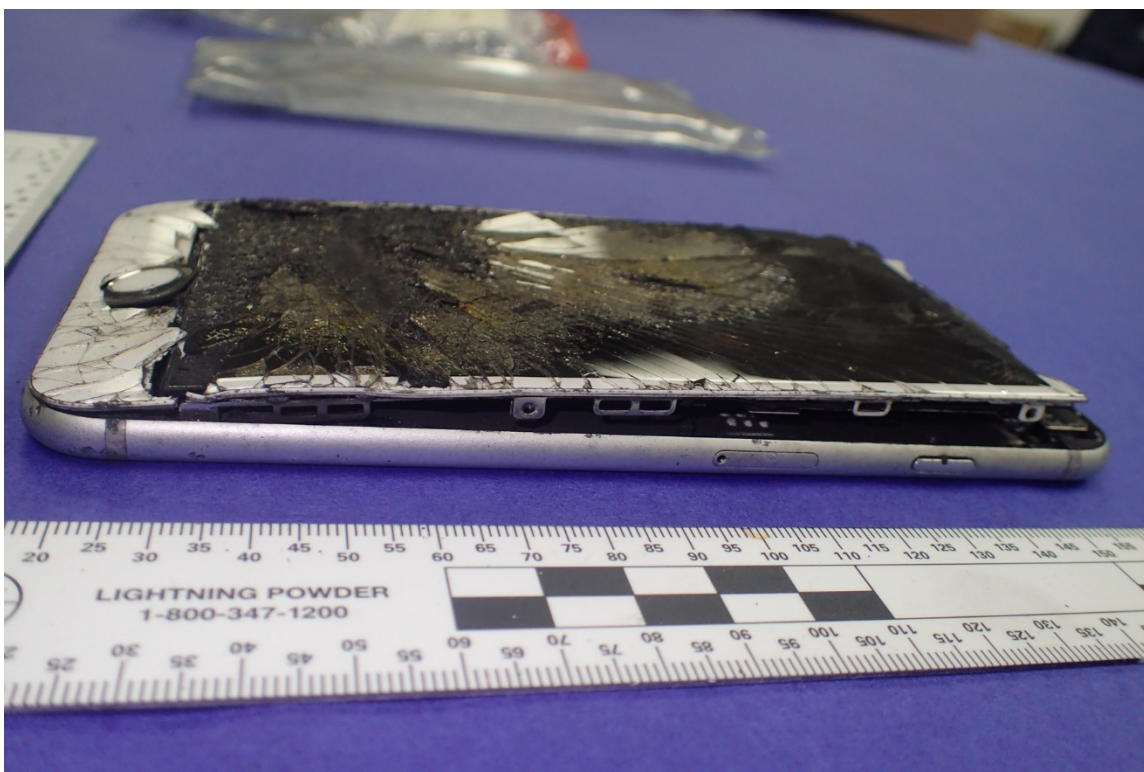
**Figure 5: Side view of the Apple iPhone 6 Plus.**

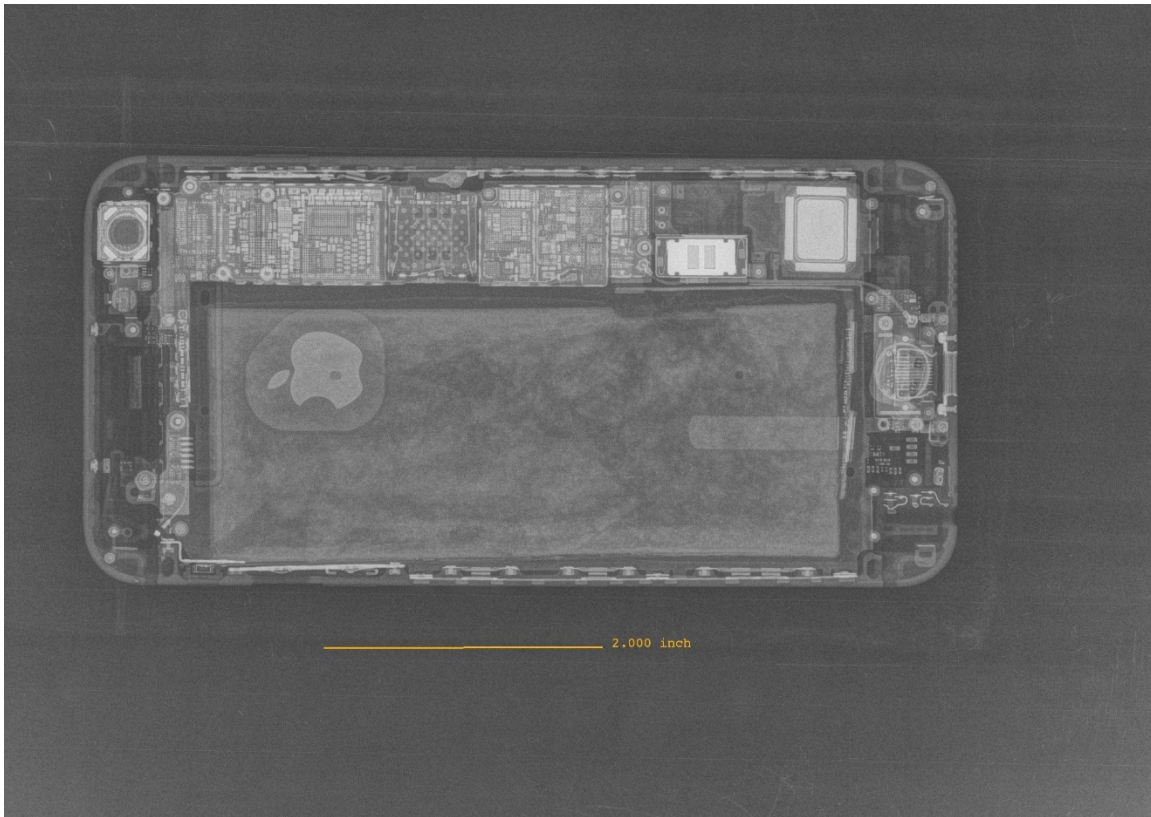
Examination of the X-Ray image for the Apple iPhone 6 Plus did not reveal evidence of an electrical malfunction associated with any of the electrical or electronic components associated with the Apple iPhone 6Plus, as seen in **Figure 6** and **Figure 7**. Close examination of the home button as well as the charging port did not reveal evidence of an electrical malfunction or failure. In addition, the interior of the subject Apple iPhone 6 Plus with the cables exposed also revealed no evidence of melting or damage, as seen in **Figure 8**. Close examination of these items as well as the X-Ray images revealed the only damage to the phone was in the screen area, away from all of the electrical and electronic components of the phone.

**Figure 6: X-Ray image of the subject Apple iPhone 6 Plus.**

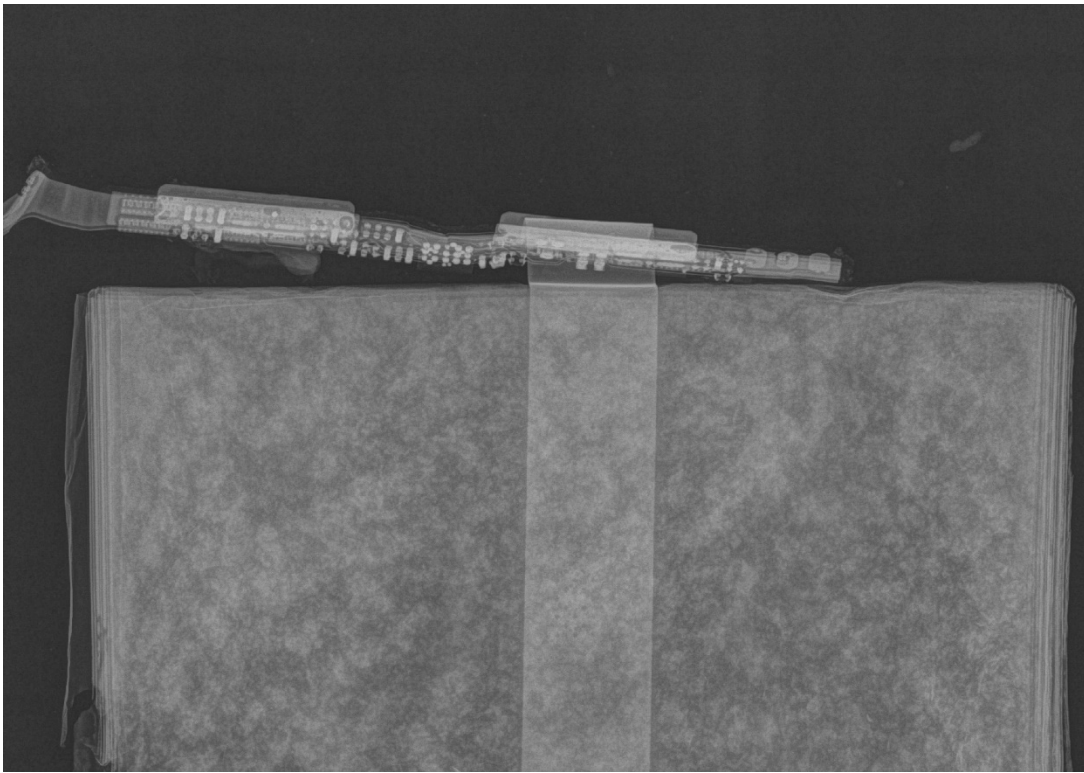
**Figure 7: X-Ray image of the subject battery cell.**

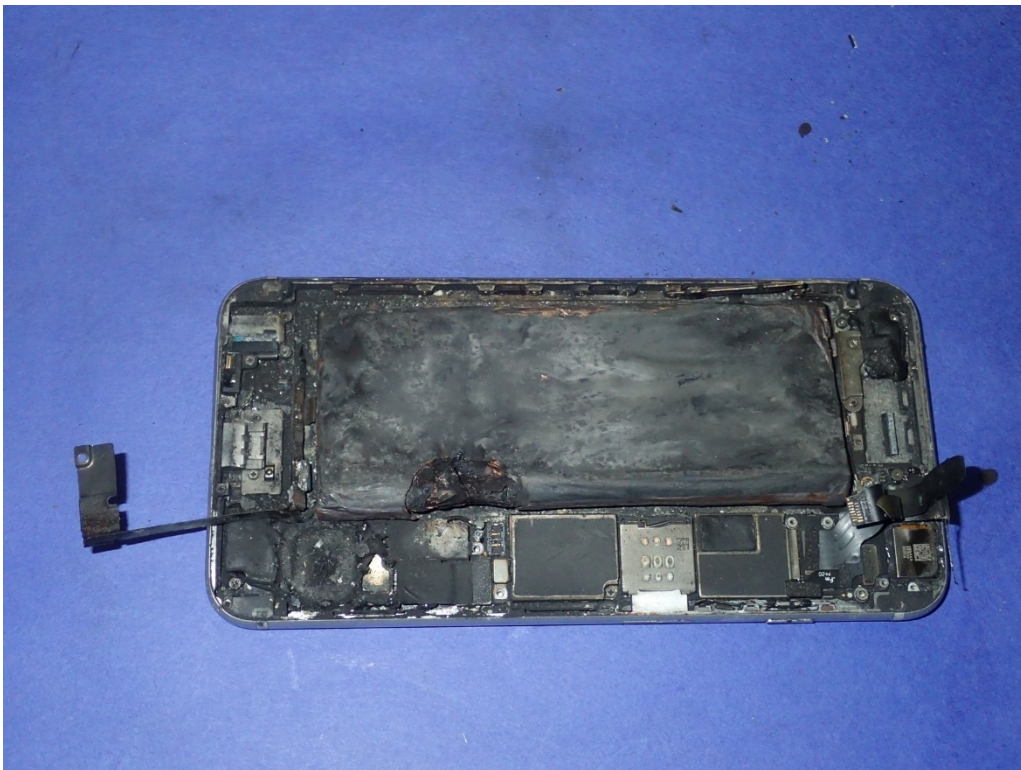
**Figure 8: Interior of the subject Apple iPhone 6 Plus revealing no damage to the plastic cables.**

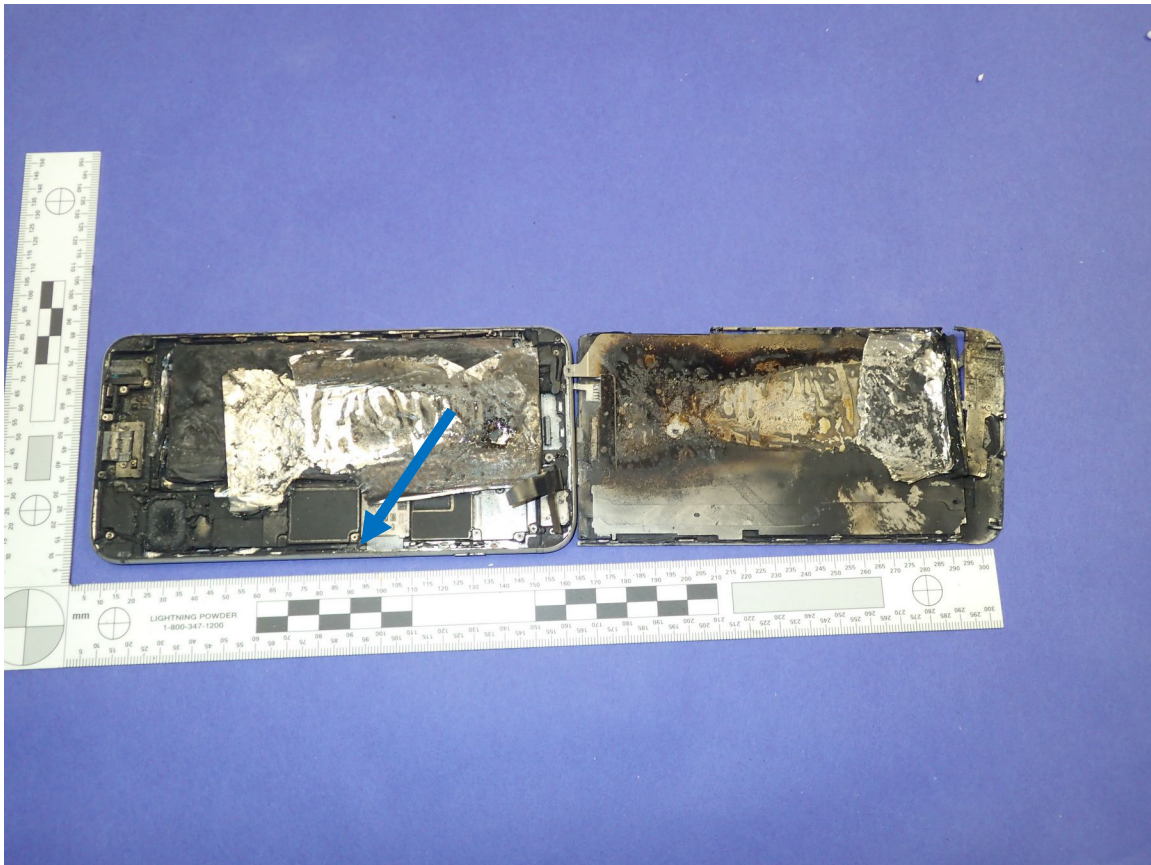
Examination of the interior of the Apple iPhone 6 Plus for the LCD screen did show physical damage away from the electrical and electronic components, as shown in **Figure 9** and **Figure 10**. Close examination of the X-Ray images revealed it was over 25mm from the top or side of the electronic components, as seen in **Figure 11**. Close examination of the subject Apple iPhone 6 Plus revealed there was an unidentified loose screw in the phone by the SIM card slot. Examination of the screw utilizing a stereo microscope revealed there was no visible damage to the screw in the form of melted metal that would have occurred if the screw had caused the damage, as seen in **Figure 12** and **Figure 13**.

**Figure 9: Remains of the subject Apple iPhone showing the main electrical control system (on left) and the LCD screen (on the right), and location of loose screw (Blue Arrow).**

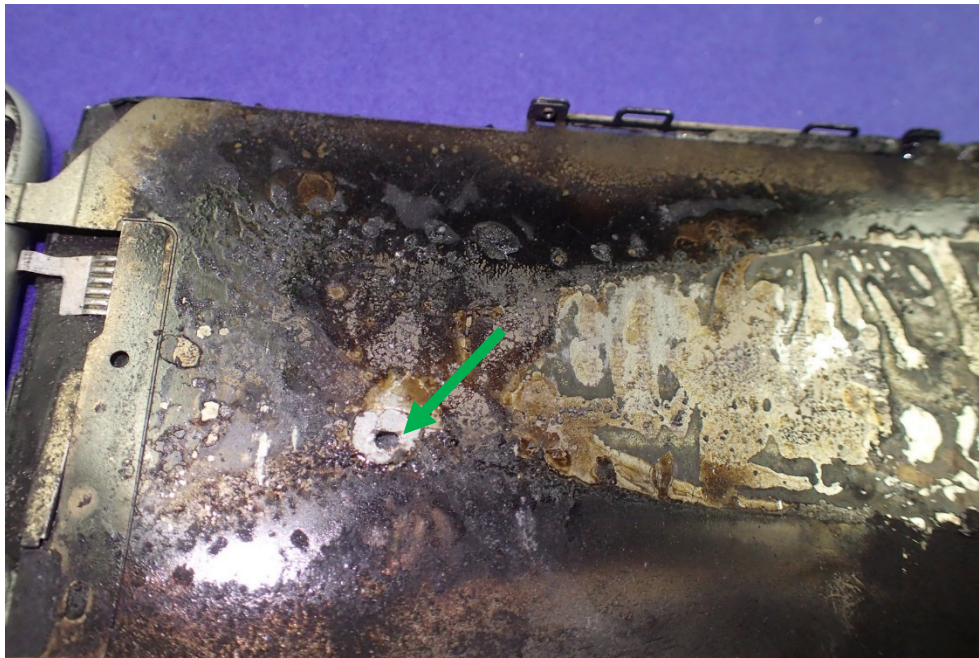
Figure 10: Closeup of damage in the form of a hole (Green Arrow).

Therefore, it is the opinion of S-E-A that the subject battery cell located in the subject Apple iPhone 6 Plus cellular phone was subjected to external damage, unrelated to work performed on the Apple iPhone 6 Plus cellular phone and battery cell, that caused an electrical failure with the battery cell resulting in the injury to Ms. McCoy.

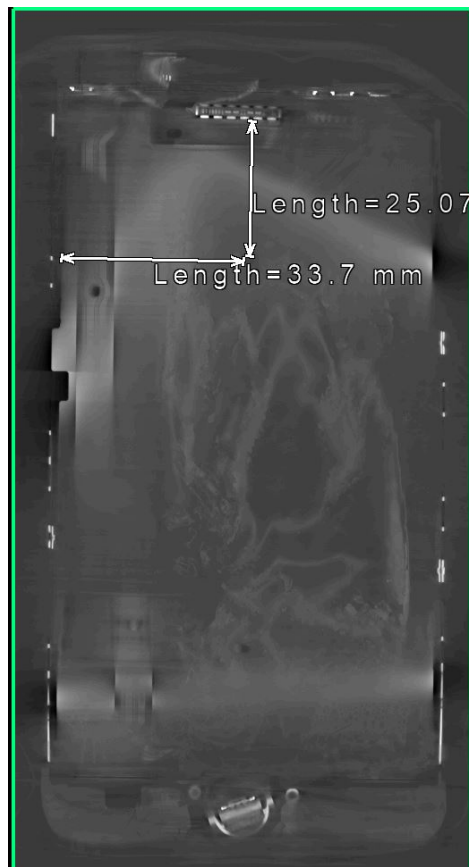
Figure 11: X-Ray with measurement of distance from electrical components and the damage at the hole.

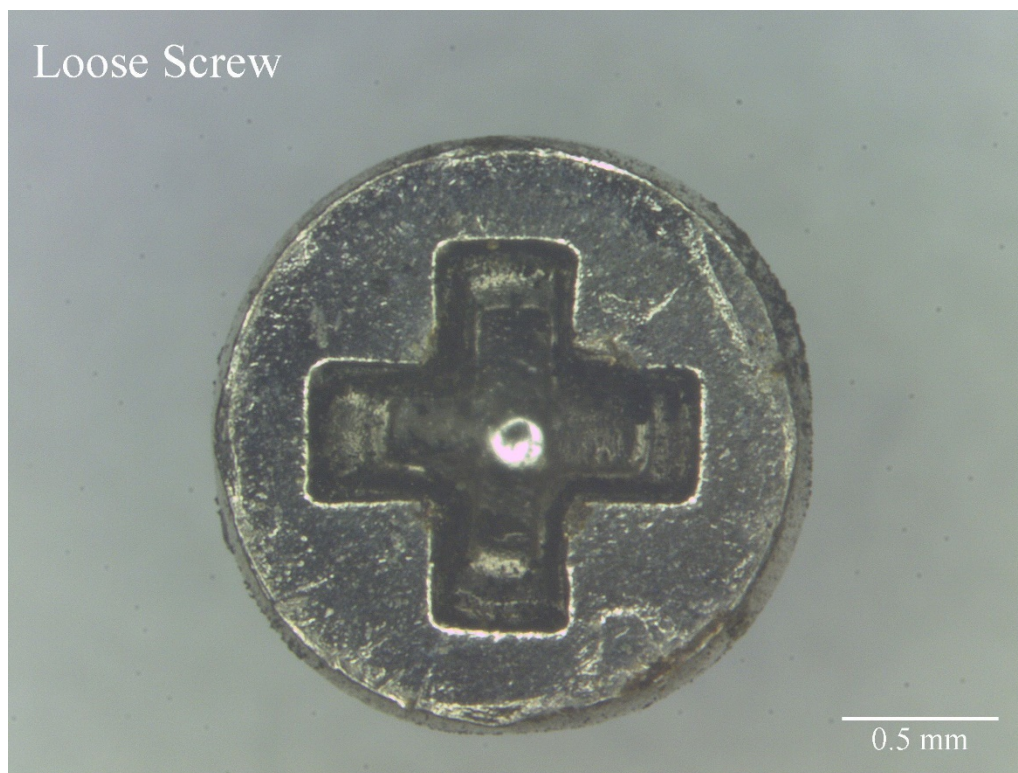
**Figure 12: Top of the Loose screw found near SIM card slot.**

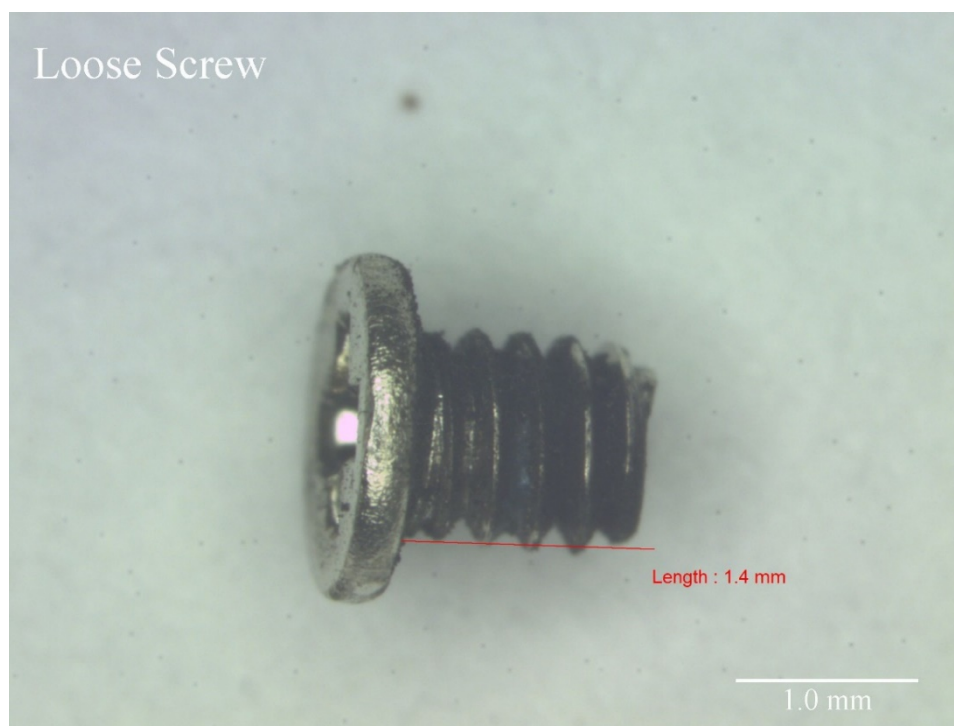
**Figure 13: Side view of the Loose screw found near SIM card slot.**
